**DEPARTMENT OF TRANSPORTATION**

Contract #: 04-0120F4Cty: SF/ALA Rte: 80 PM: 13.2/13.9File #: 69.28**WELDING INSPECTION REPORT****Resident Engineer:**Siegenthaler, Peter**Address:** 333 Burma Road**City:** Oakland, CA 94607**Report No:** WIR-025179**Date Inspected:** 28-Jun-2011**Project Name:** SAS Superstructure**OSM Arrival Time:** 1900**Prime Contractor:** American Bridge/Fluor Enterprises, a JV**OSM Departure Time:** 700**Contractor:** Zhenhua Port Machinery Company, Ltd (ZPMC), Changxing Island **Location:** Shanghai, China**CWI Name:** See Below**CWI Present:** Yes No**Inspected CWI report:** Yes No N/A**Rod Oven in Use:** Yes No N/A**Electrode to specification:** Yes No N/A**Weld Procedures Followed:** Yes No N/A**Qualified Welders:** Yes No N/A**Verified Joint Fit-up:** Yes No N/A**Approved Drawings:** Yes No N/A**Approved WPS:** Yes No N/A**Delayed / Cancelled:** Yes No N/A**Bridge No:** 34-0006**Component:** OBG**Summary of Items Observed:**

Blast bay #4, OBG segments 13AW, 13BW and 13CW

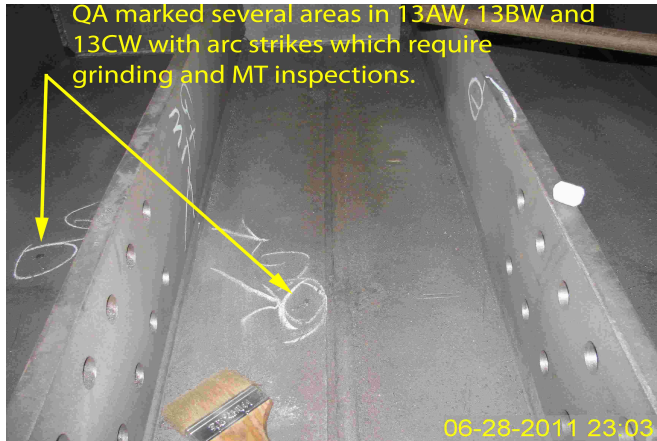
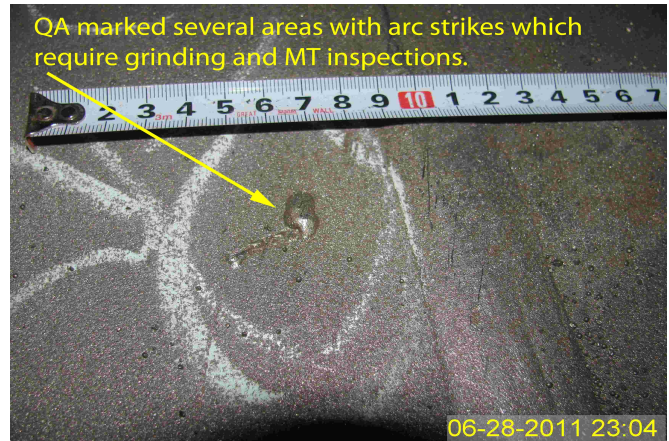
ZPMC requested Caltrans personnel to perform visual inspections of OBG segment 13AW, 13BW and 13CW between PP120 and PP124.5 bottom plates and adjacent longitudinal diaphragms up to a height of approximately two meters at 22:30 hours following the initial pre-blast cleaning of the steel surfaces. This QA Inspector along with three other QA Inspectors performed random visual inspections of these areas and observed multiple areas that require grinding to remove arc strikes, sharp edges, minor gouges and three areas that require weld repairs. Caltrans QA Inspectors' issued a "Blast Inspection" incident report to document the weld repairs. Several ZPMC workers used electric grinders to blend the areas that had been marked by ABF and QA Inspectors.
